KLIMKOVICKÝ TUNEL UVEDEN DO PROVOZU

KLIMKOVICE TUNNEL INAUGURATION

JIŘÍ PECHMAN, JAN STACH, ONDŘEJ HORT, DAVID POHLODEK, JOSEF ALDORF

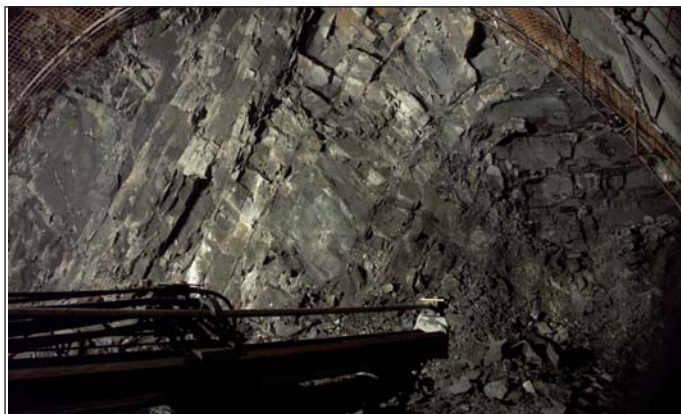
Obr. 4 Strmě uložené aleuropelity v čelbě kaloty s antiformní strukturou vpravo – tunelová trouba B, km 141,864 (foto Stach)

Fig. 4 Steeply dipping aleuropelites at the top heading face Strmě uložené aleuropelity v čelbě kaloty s antiformní strukturou vpravo - tunelová trouba B, km 141,864 (photo Stach)

Ražba tunelu probíhala ve skalním podloží neproduktivního karbonu–kulmu. Typickým horninovým prostředím byla kombinace pelitických jílovců a prachovců s drobnými pískovci ve formě flyšových souvrství (obr. 4). Právě toto rytmické flyšové střídání jílovitých a pískovcových vrstev je pro Ostravsko typické a přináší geotechnické potíže a problémy.

The tunnel excavation passed through the bedrock formed by the Non-Productive Carbonaceous Ě Culm Measures. A combination of pelitic claystone and siltstone with greywacke and subgreywacke in the form of flysh measures (see Fig. 4) was typical of the rock environment. This rhythmical flysh alternation of claystone and sandstone, which causes geotechnical problems, is typical of the Ostrava region.

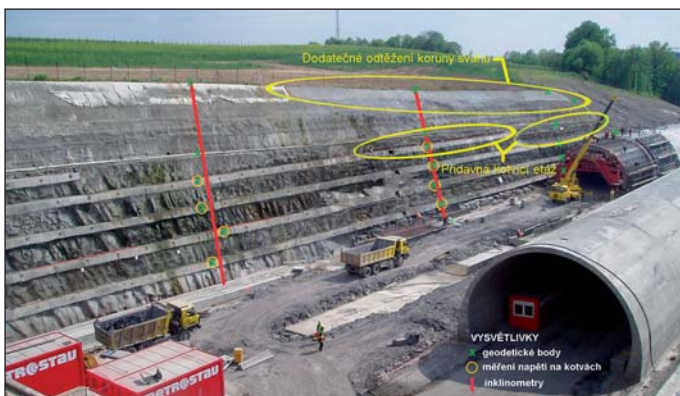
Obr. 6 Schéma rozmístění prvků monitoringu na části jižní stěny stavební jámy hloubeného úseku Brno společně s naznačenou lokalizací dodatečných opatření pro sanaci svahu (foto Stach)

Fig. 6 A chart of the locations of the monitoring elements on a part of the southern slope of the construction trench for the Brno-side cut and cover section, together with the locations of the additional slope stabilisation measures (photo Stach)

Měřením nebyly zjištěny deformace do stavební jámy nad rámec varovného stavu. Výjimku představuje inklinometr JI-2 vpravo v jámě Brno ve staničení 141,240. Významné deformace byly zaznamenány v hloubkovém

No movements toward the construction trenches exceeding the trigger limits were identified by the measurements. The inclinometer JI-2, which was installed on the right side of the Brno-side trench at chainage km 141.240, was an exception. Significant deformations were observed within the depth interval ranging from -7.0 m to -5.0 m. The deformations which developed at the depth levels -6.0 m and 2.0 m being monitored reached 22 mm and 30 mm respectively in July 2005. The accelerated increase in deformations of the right slope also confirmed that the additional anchoring of the above-mentioned part of the trench was necessary.
